WOOD-DESTROYING ORGANISMS INSPECTION REPORT

888 Main Street

Report ID # 28749

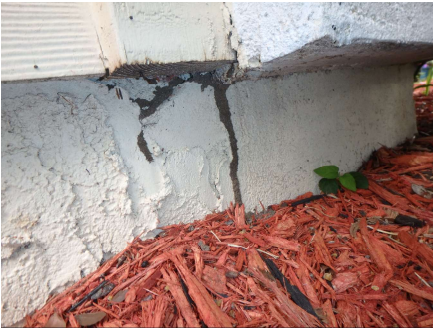
shelter tube - front of home

Comments: (Use additional pages, if necessary)
Live Eastern Subterranean termites found on front and left side of home and inside garage on left wall.
Recommend additional investigation and treatment.

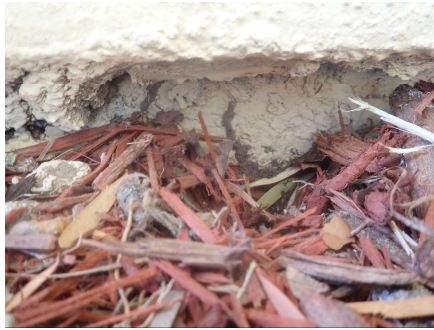
shelter tube - left side of home

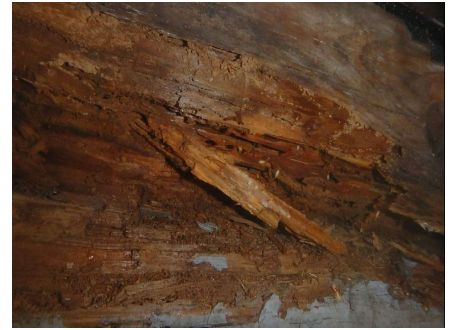
live sub-termites - framing/sheathing

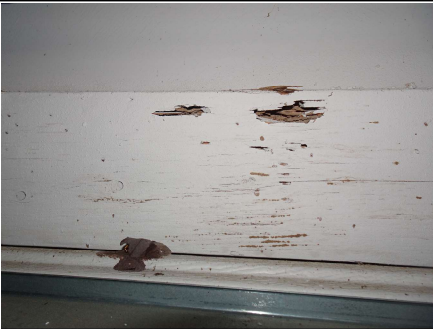
sub-termite galleries in garage

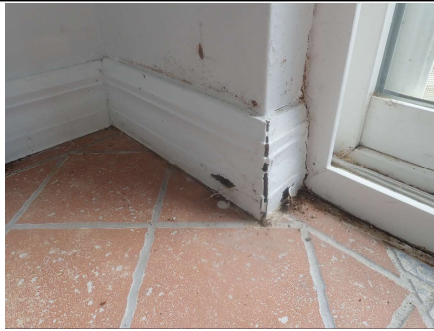
galleries/frass inside home

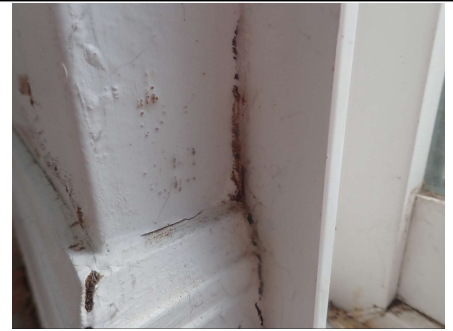
galleries/frass inside home
